Sinking of Nordhavn 75 – hull #2

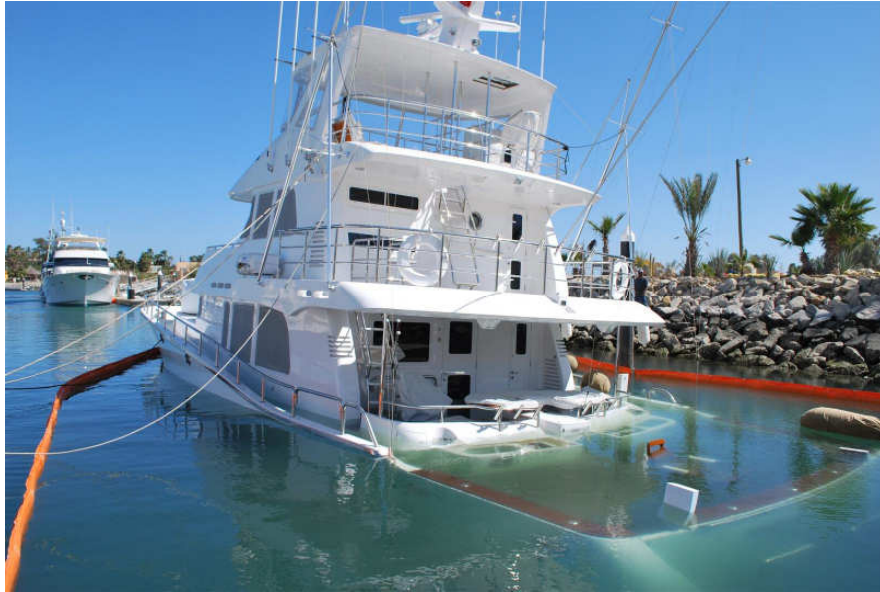
The boat sunk at about 10:00 pm on Thursday the 3rd of February 2011.

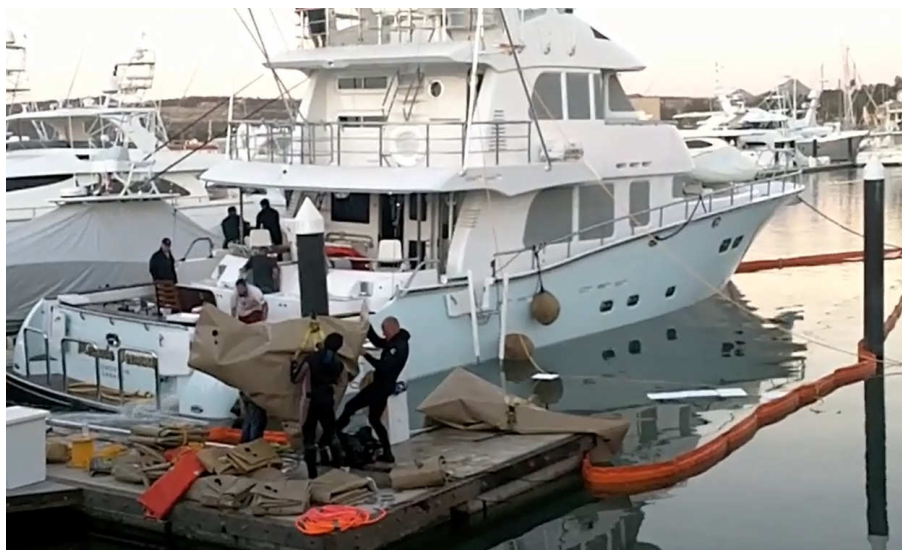
By Sunday the 6th of February at about 6:00 pm she was refloated.

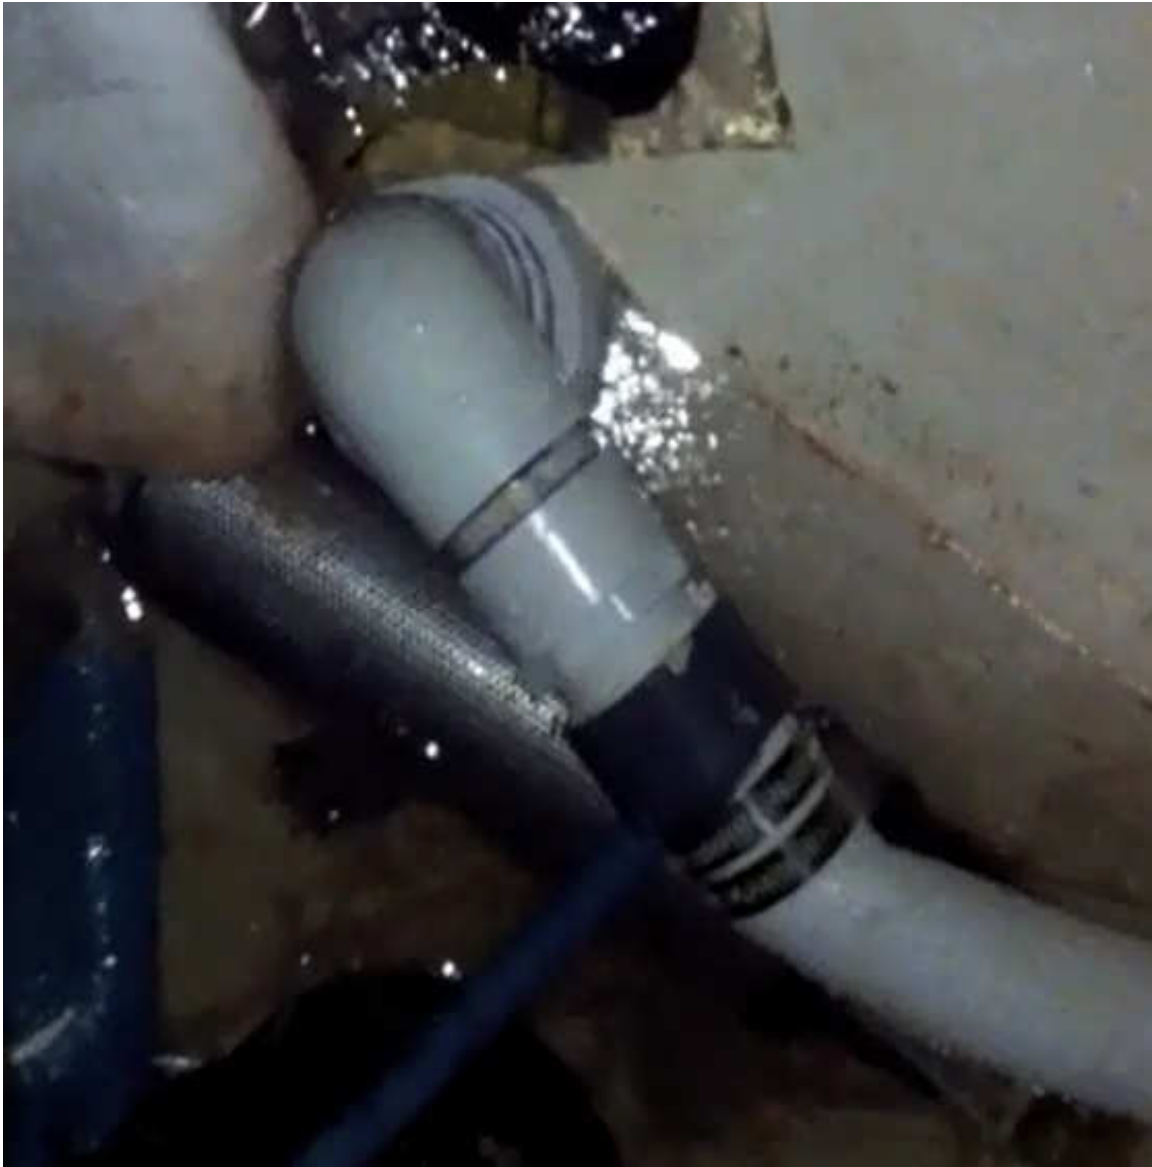
On Sunday morning prior to the refloating a diver entered the engine room and reported that a large PVC fitting has popped off of a large pump and that was the source of the leaking.

When access was possible photos were taken. The photo above shows the PVC fitting with a Sealand sanitation hose attached. The fitting was loose and laying in the bilge below the engine room floor. The diver had noted the through hull was open and he closed it before they attempted to raise the boat. The diver also noted that the water tight door between the engine room and the lazarette was open.

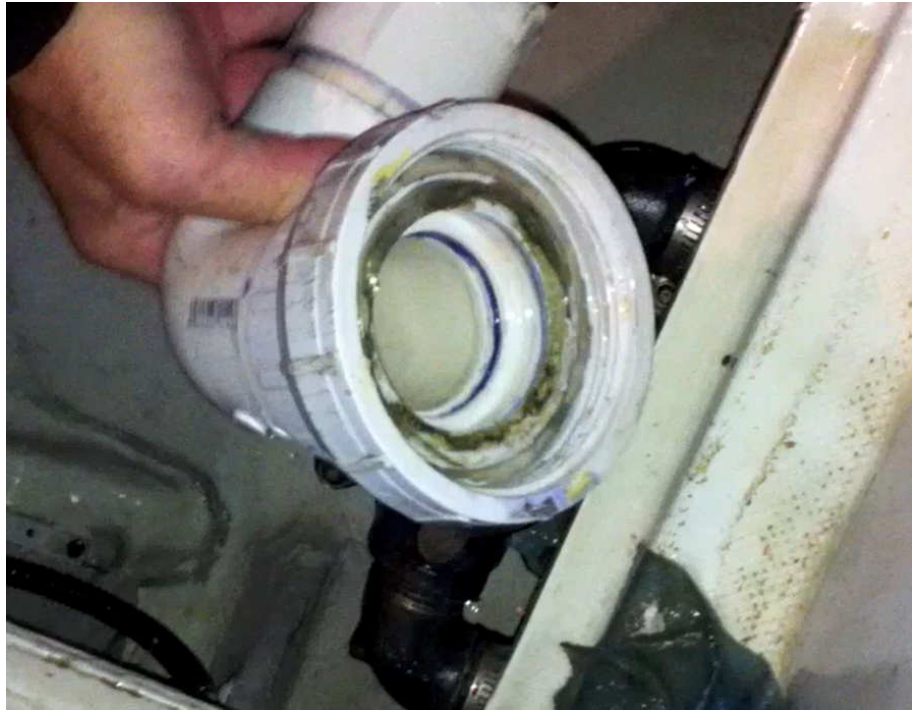
The photo above shows the fitting lifted and the detail can be seen.

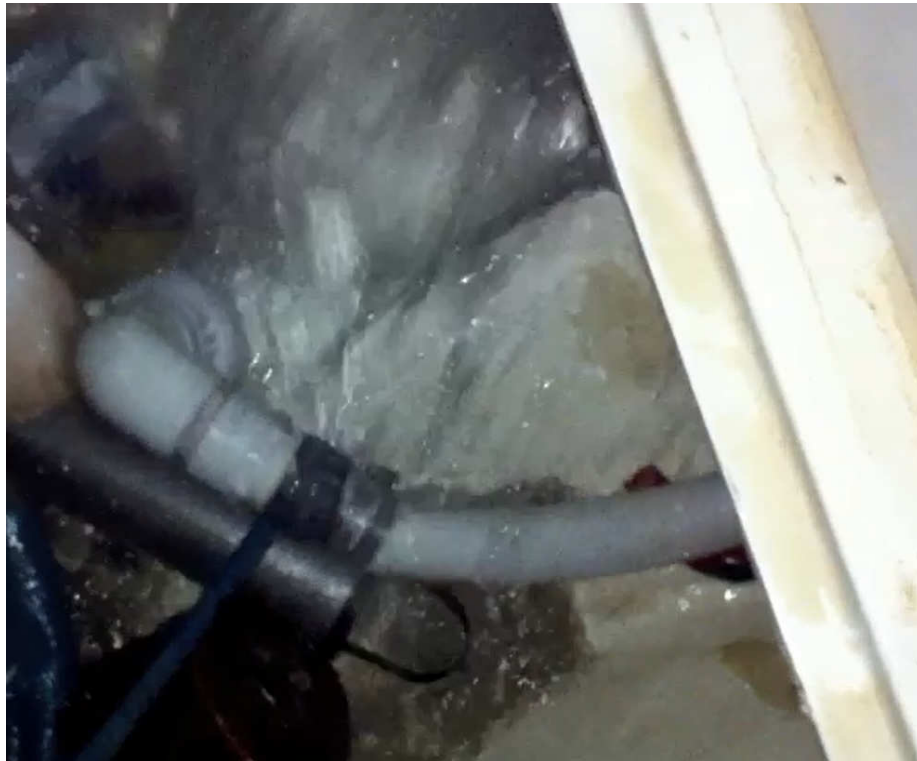
The photo above shows the incoming water when the thru hull was temporarily opened to observe the water flow. Water is flowing out of the pump which is mounted under the engine room floor - in the upper right of the photo. The pump is plumbed directly to the thru hull and is approximately three to four feet below the static waterline. The fitting shown is attached to a Sealand hose and runs up to the Tuna Tube bait system located in the cockpit. The pump is hard plumbed to the two inch thru hull and valve with no inline strainer.

The calculation below shows that a two inch hole with a four foot head of pressure - will allow water to flow at 9,200 gallons per hour. As the vessel sank lower the flow would have increased.

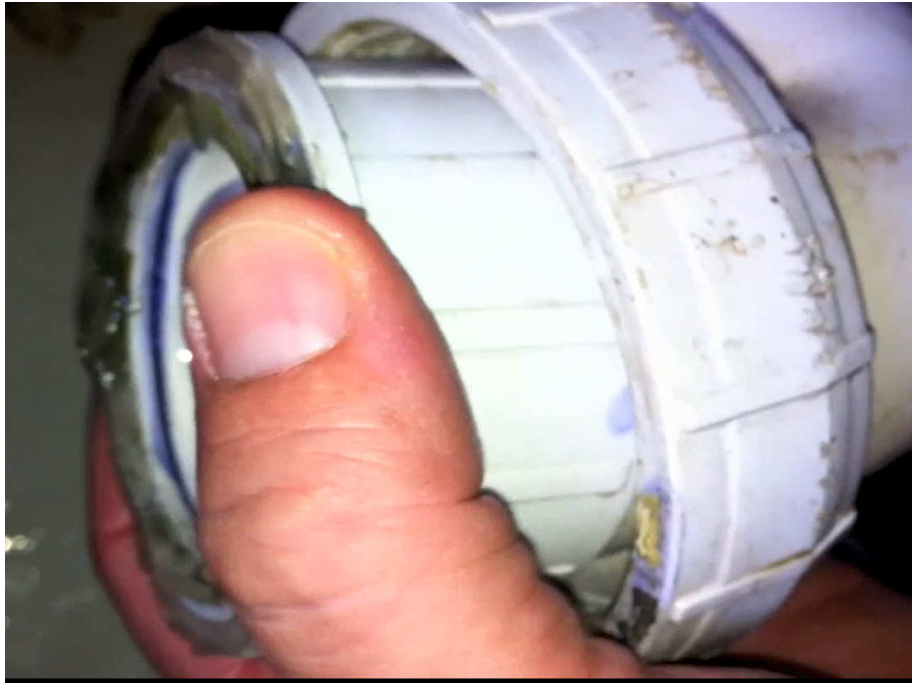
The above photo shows the PVC fitting with the threaded collar that screws over the male threads of the pump outlet. This fitting is similar to what's commonly seen on the bottom of a kitchen sink drain.

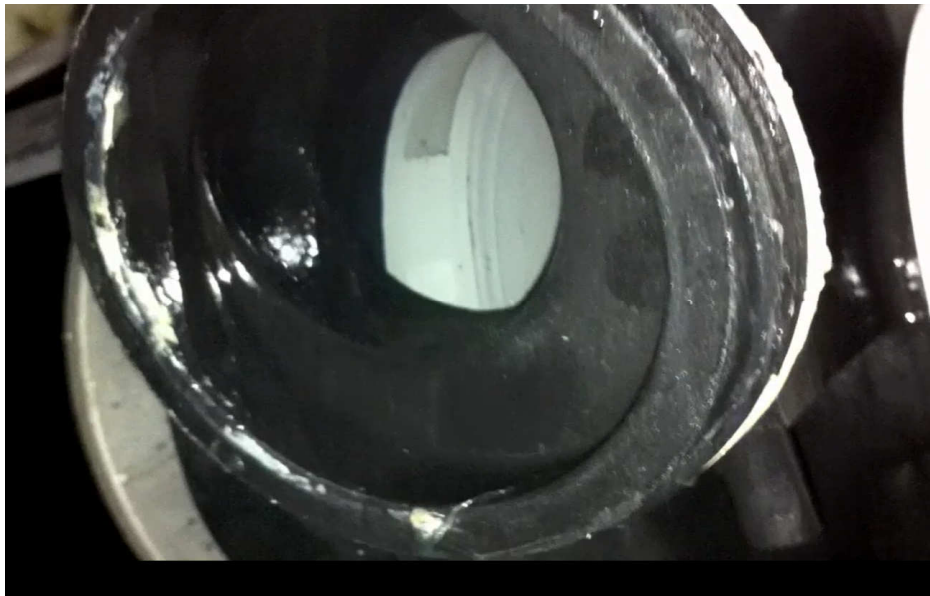
The photo below shows the male threads of the centrifugal pool pump that the above fitting was attached to.
